PROPERTY RESTORATION

First Congregational United Church of Christ Vancouver, Washington

Loss Event: Arson Fire

CASE STUDY

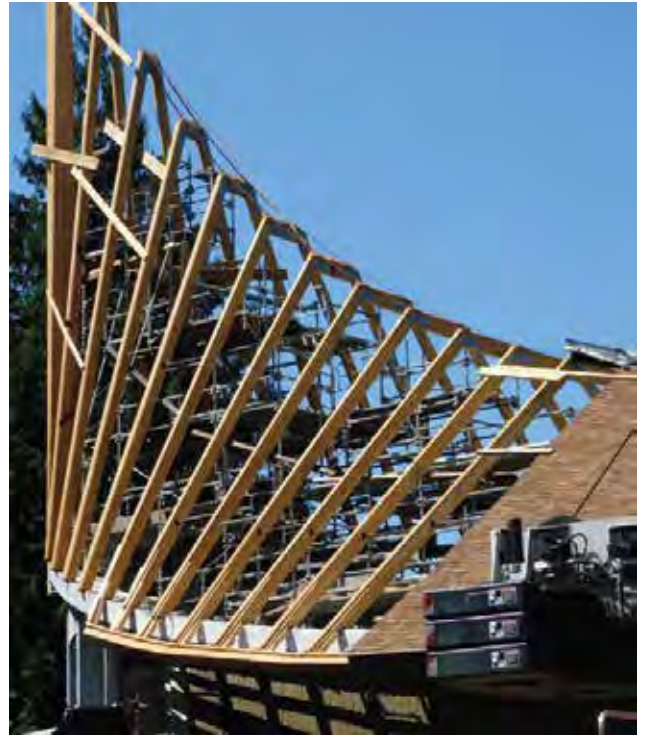
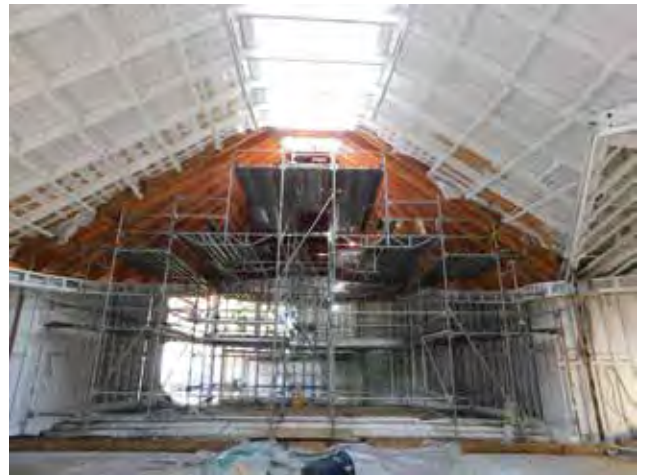
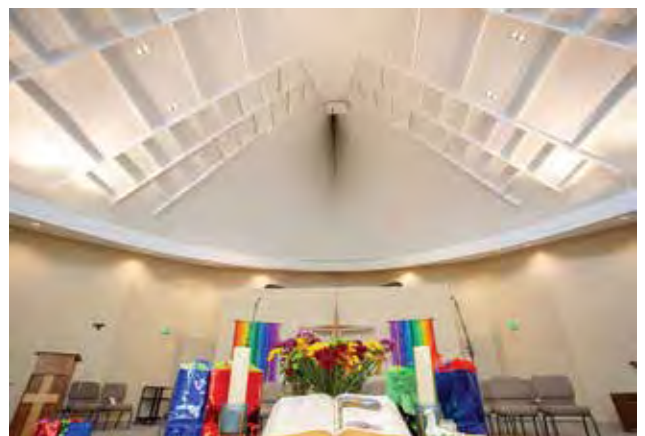
Given the curved and arched nature of the structure, BELFOR was tasked to bend the drywall into shapes not typically found. Because scaffolding prevented BELFOR from being able to bring in equipment, lifts, and machinery, these materials were all set in place by hand.

Acoustic designers worked with BELFOR to seamlessly incorporate acoustic panels into the curved ceiling system. Wood trim pieces were installed on edge along the ceiling lines to create a random grid pattern ceiling design. Hidden within these grid panels are acoustic sound treatments which help remove the echoing sound from the large room.
